Conroy, Jon and Chawda, Mayur and Kaushal, Rishi and Whitehouse, Sarah and Crawford, Ross W. and English, Hugh (2008) *Does Use of a "Rim Cutter" Improve Quality of Cementation of the Acetabular Component of Cemented Exeter Total Hip Arthroplasty?* *Journal of Arthroplasty*, 24(1). pp. 71-76.

Does use of a “Rim Cutter” improve quality of cementation of the acetabular component of cemented Exeter THA?

A prospective randomized controlled trial

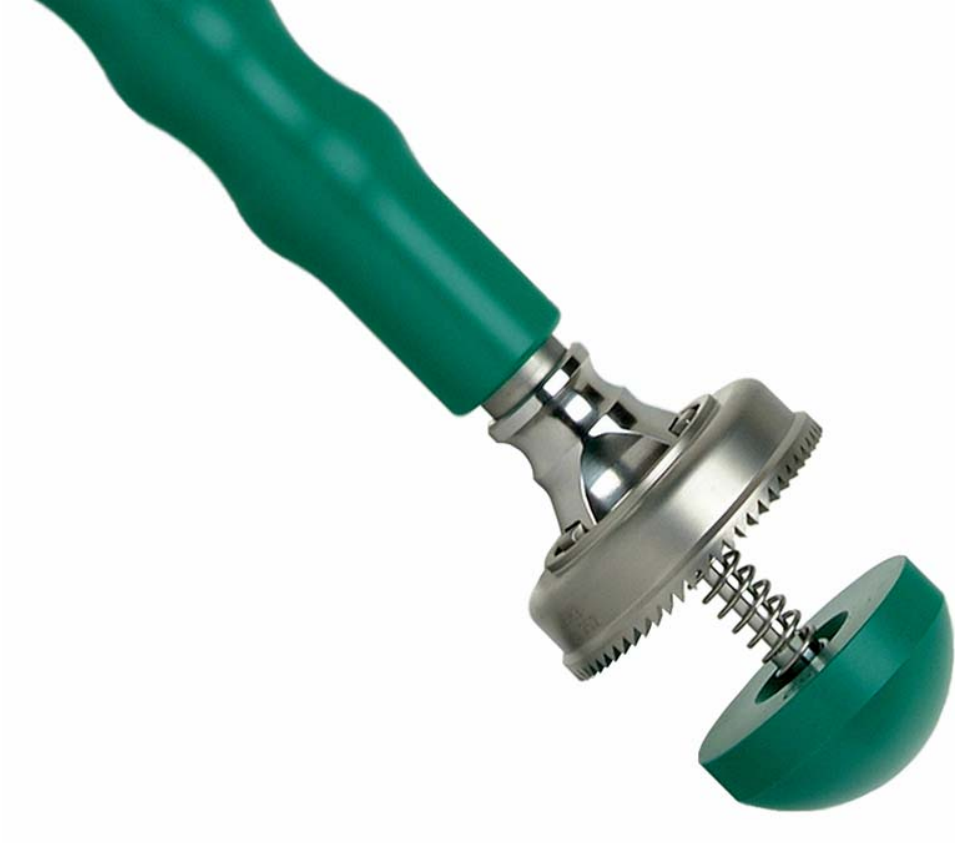
Figure 1. The rim cutter device.

The rim cutter is a device designed to cut a shelf or rim in the acetabular rim to allow the flange to seat accurately. [Figures 1-3] It was developed to try to improve the cement mantle quality, improve the accuracy of cup centering, reduce the incidence of bottoming out, and allow a trial reduction with a cemented component (the flange in the rim allows a trial reduction prior to cementing in a similar way to a trial uncemented liner).

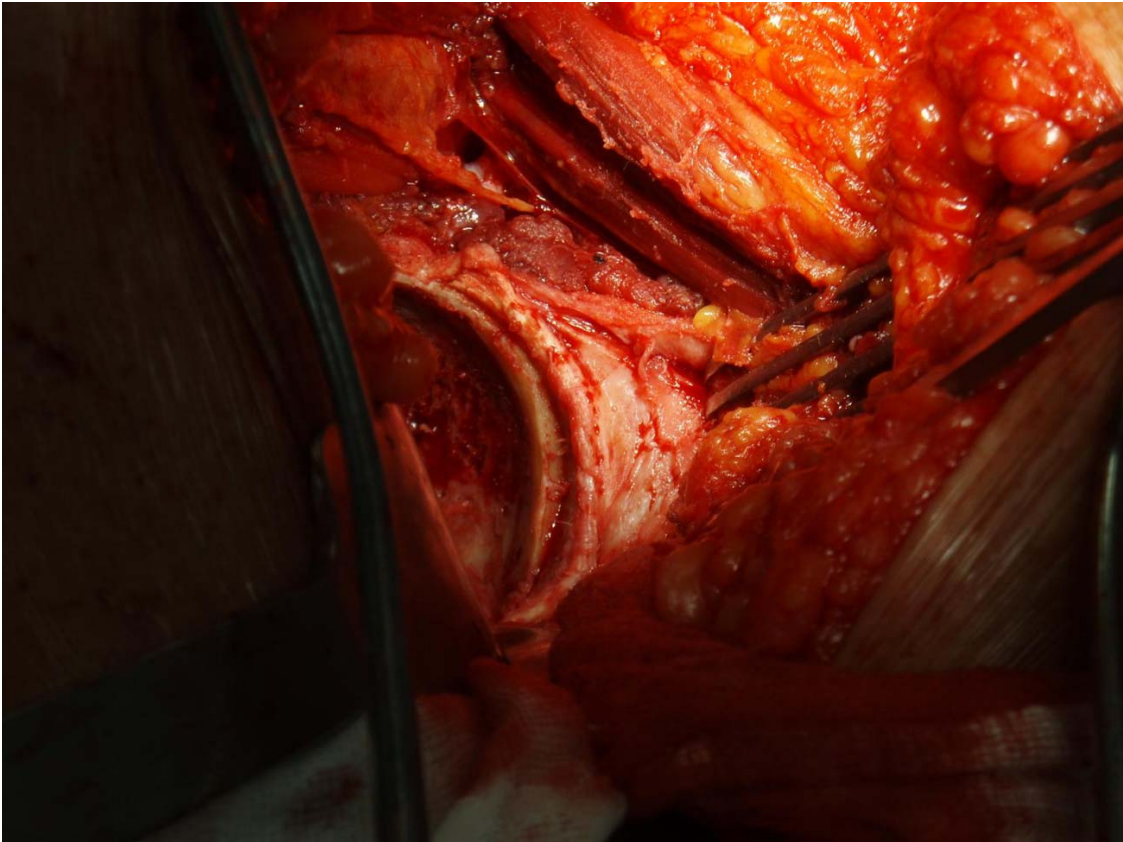
Figure 3. The rim in the acetabulum seen after use of the rim cutter

At this stage in the rim cutter group, a rim was cut along the acetabular margin using the rim cutter device. A flanged cup (Contemporary cup -Stryker) of appropriate size (generally 2mm smaller than the last reamer) was prepared for insertion by trimming the flange as required. The flange was cut to fit inside the acetabulum in the control group. In the rim cutter group a 2mm rim of flange was preserved to sit on the cut acetabular rim.
