Typological characterisation of vintage unreinforced masonry buildings of Queensland, Australia.

Structures, 41, pp. 99-116.

TYPOLOGICAL CHARACTERISATION OF VINTAGE UNREINFORCED MASONRY BUILDINGS OF QUEENSLAND, AUSTRALIA

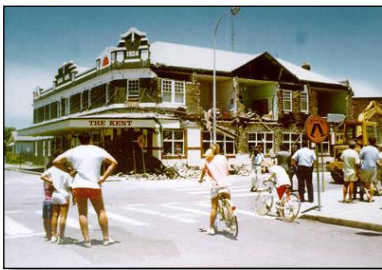
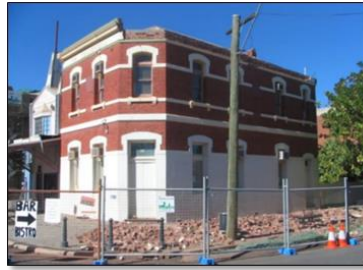
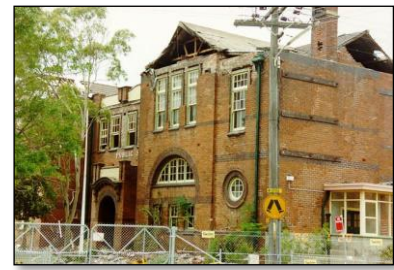
a) Kent hotel after the 1989
Newcastle, NSW
earthquake (M_L 5.6)

b) The commercial hotel
after the 2010
Kalgoorlie Boulder,
WA earthquake (M_L
5.0)

c) The Junction public
school after the 1989
Newcastle, NSW
earthquake (M_L 5.6)

335 Figure 4. Performance of non-structural URM building components during past Australian
336 Earthquakes.

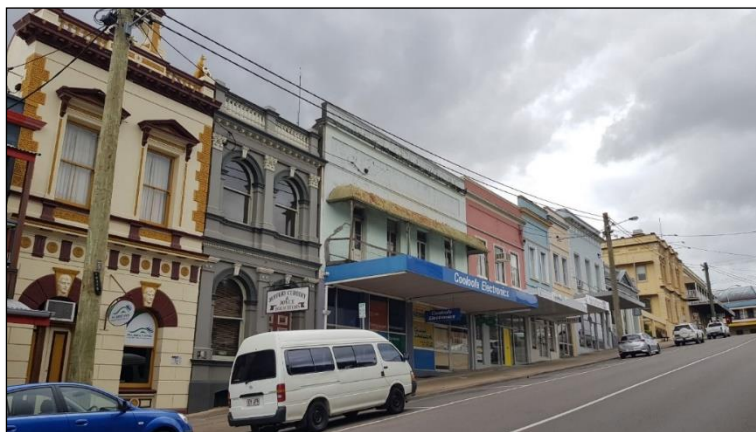
Figure 8. Inter-connected buildings in Gympie

About 91% of the buildings were interconnected, with no separation gaps between two adjacent buildings (see Figure 8). This condition is likely to result in pounding-related damage during an earthquake (Cole et al. 2012, Shrestha and Hao 2018), especially when floor levels are different as shown in Figure 8.

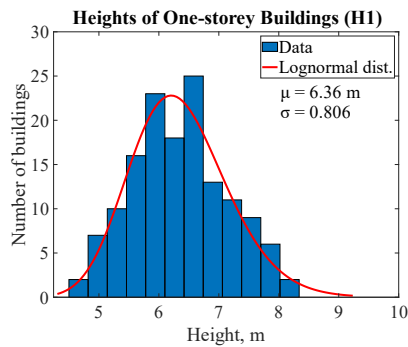
a) Heights ($H1$) of one-storey buildings

b) Heights ($H1$) of two-storey buildings

c) Heights ($H2$) of one-storey buildings

d) Heights ($H2$) of two-storey buildings

Figure 12. Building heights distributions.

The mean for heights $H1$ and $H2$ in one-storey buildings were, respectively, 6.35m and 7.25m, and these parameters were, respectively, 10.09m, and 10.93m for two-storey buildings.

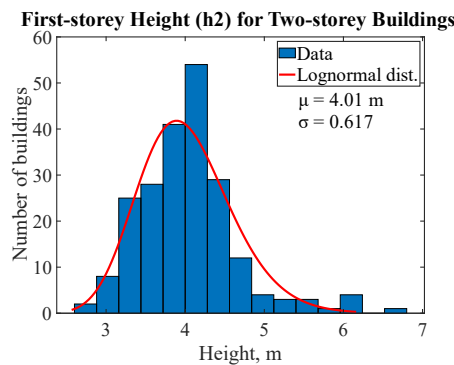
a) Ground-storey heights (h1) for one-storey buildings

b) Ground-storey heights (h1) for two-storey buildings

c) First-storey height (h2) for two-storey buildings

Figure 13. Storey heights distributions.

The mean storey height was between 4.0 m and 4.65 m, with mean h1 being 4.65 m and 4.53 m, respectively, for one-storey and two-storey buildings. The mean h2 in two-storey buildings was found to be 4.01m.

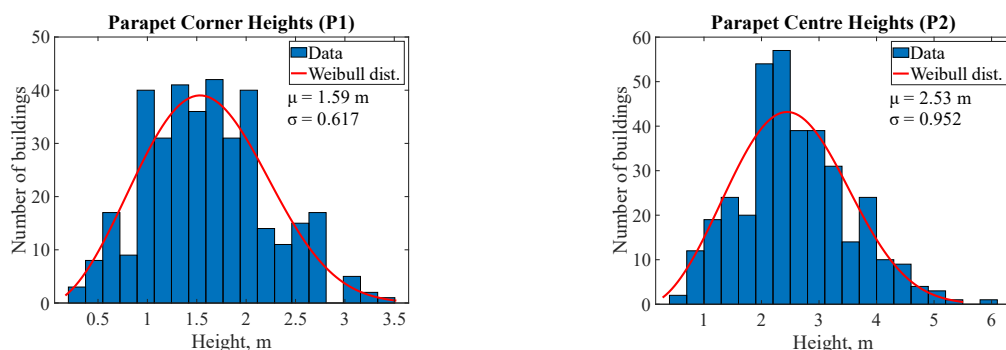
a) Parapet corner heights (P1)

b) Parapet centre heights (P2)

Parapet heights (P1 and P2) were measured from the roof line/eaves and are reported in Figure 14. The mean parapet corner height, P1, and parapet centre height, P2, were, respectively, 1.59m and 2.53m.

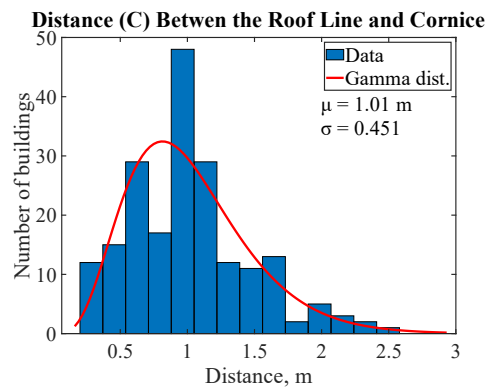
Figure 15. Distance (C) between the roof line and cornice.

A common perception in visual building observations is that the roof line is situated along the cornice, which is a projected portion seen at the top of the façades (see Figure 16). It was found during the survey that the roof line is situated within a mean distance C of 1.018 m (see

distribution in Figure 15) below the cornice. This type of construction results in a relatively tall cantilever masonry parapet.

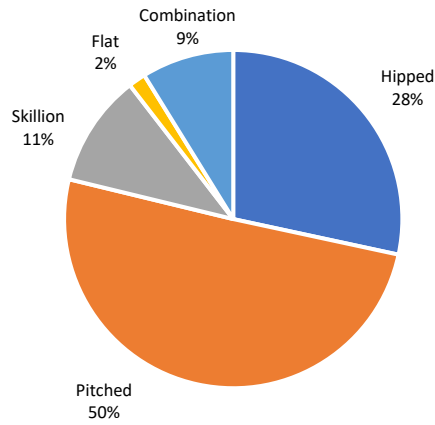
Figure 17. Distribution of type of roofs in URM Buildings.

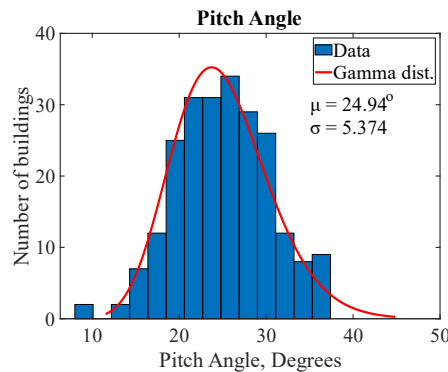
Figure 20. Pitch angle distributions.

For some buildings, several hipped and pitched roof sections were connected to a single façade. The number of these occurrences is reported in Table 2 and shown in Figure 18, where for example 3P refers to a façade being connected to 3 pitched section of a roof. In some instances, the pitched roof was off-centre of the parapet as shown in Figure 19. In addition, the roof pitch angle was determined using façade measurements. It was found that the pitch angle of the pitched roof for the majority of the URM buildings was between 20° and 30° as shown in Figure 20, with the mean value of 24.94°.

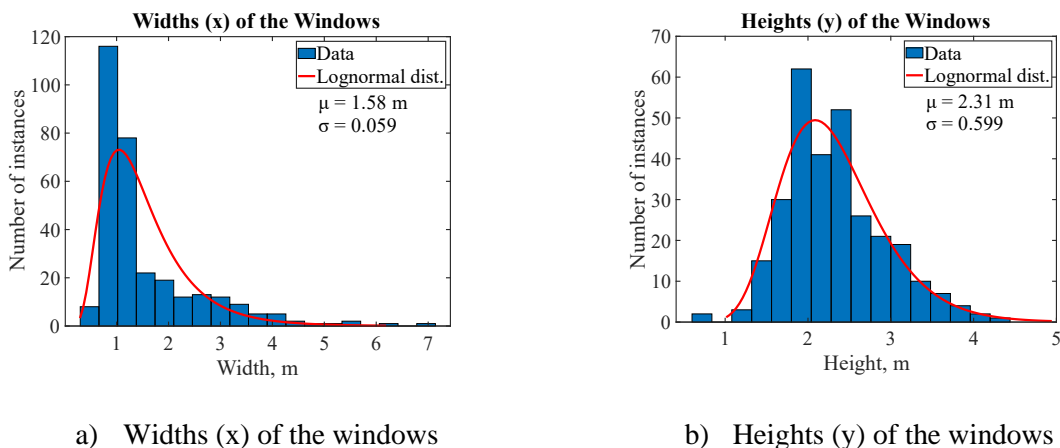
Figure 29. Distribution of windows dimensions.

From the surveyed photographs, it was found that 67% of the buildings had regular window openings but that the rest of the buildings (33%) had a large shop-front opening. The window openings are either rectangular/square (46% of buildings), arched (15% of the buildings) or a mix of both forms (6% of the buildings). Window dimensions were measured, with a summary reported in Figure 29. The mean window width (x in Figure 11) and height (y in Figure 11) are 1.58m and 2.31m, respectively. Figure 30 shows the façade opening ratio that was calculated from measurements, with the mean value being 0.336.

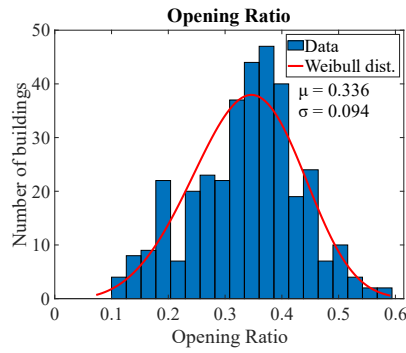
Figure 30. Distribution of façade opening ratio.
