Abbas, Muntazir, Rizvi, Syed Haider Mehdi, Sarfraz, Shoaib, Raza, Asif, Khan, Asif, Loya, Adil, & Najib, Antash
(2024)

Evaluation of the influence of dissolved nitrates on corrosion behaviour of ship structural steel exposed to seawater environment.
Ocean Engineering, 298, Article number: 117268.

Evaluation of the influence of dissolved nitrates on corrosion behaviour of marine steel exposed to a seawater environment

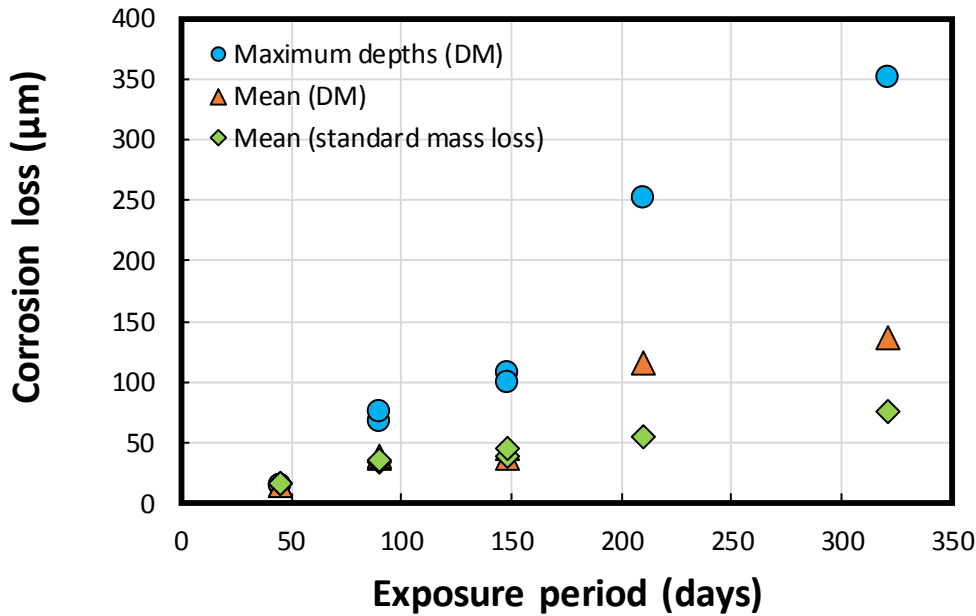
The corrosion losses on steel coupons were evaluated on C-series steel coupons, after their immersion in an un-nitrated artificial seawater for various durations up to a maximum of 321 days. Figure 4 shows maximum pit depths and mean corrosion loss parameters calculated using DM-micrometry and standard mass loss methods.

Figure 4 Corrosion loss parameters calculated for steel coupons (C-series) exposed to the un-nitrated artificial seawater

Overall, the corrosion loss patterns shown in Figure 4 and Figure 5 show that the maximum corrosion depth and the mean corrosion loss parameters (calculated using both DM-micrometry and standard mass loss methods) were found to be considerably higher in case of steel coupons exposed to the nitrated artificial seawater.

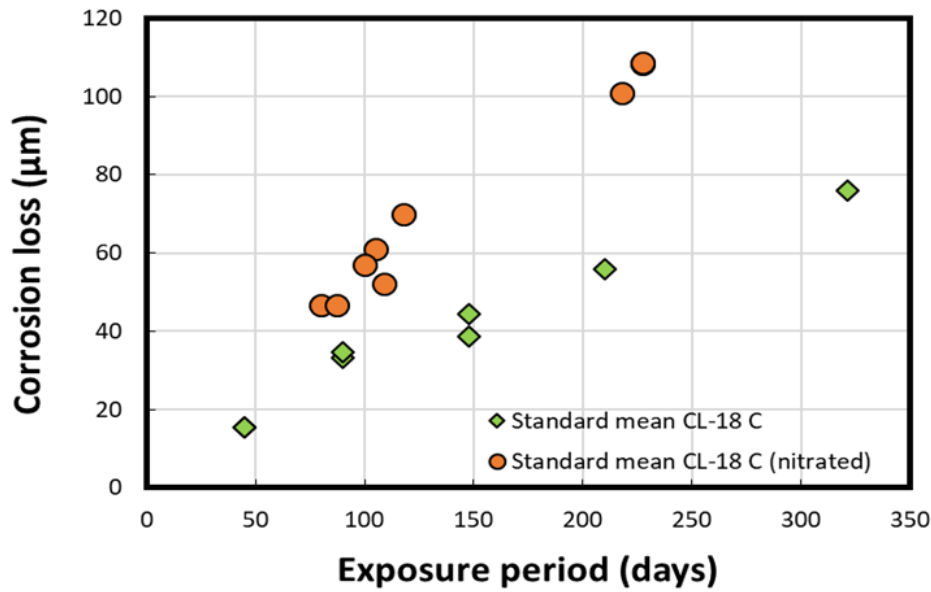
Additionally, Figure 6 and Figure 7 show the comparative graphs for mean corrosion loss and maximum depths on steel coupons, exposed to the nitrated artificial seawater (J-series) and the un-nitrated artificial seawater (C-series), respectively. These loss parameters were then calculated using the standard mass loss and the DM-micrometry methods. The mean corrosion rates were ranged between 0.33-0.42 mm/y when exposed to nitrated artificial seawater for a duration up to a maximum of 227 days, whereas for similar duration it ranged between 0.1-0.15 mm/y in a seawater medium without nitrate content.

Figure 6 Comparison of mean corrosion losses observed on steel coupons exposed to the nitrated artificial seawater (J-series) and the un-nitrated artificial seawater (C-series), and calculated using standard mass loss method. Here 'CL' indicate corrosion loss

Overall, Figures 6-9 indicate that the mean corrosion losses and maximum depths were found to be significantly higher on steel coupons exposed to the nitrated artificial seawater (for a maximum duration of 227 days), than those exposed in similar seawater compositions (un-nitrated), even after exposure for extended durations of up to a maximum of 321 days. Most importantly, one of the limitations being experienced during the laboratory based corrosion experiments (at Cranfield University U.K), where the maximum exposure duration of steel coupons (J-series) dipped in nitrated seawater could not be extended beyond 227 days because of the lockdown situation due to COVID-19 and safety practices adhered in research laboratories.

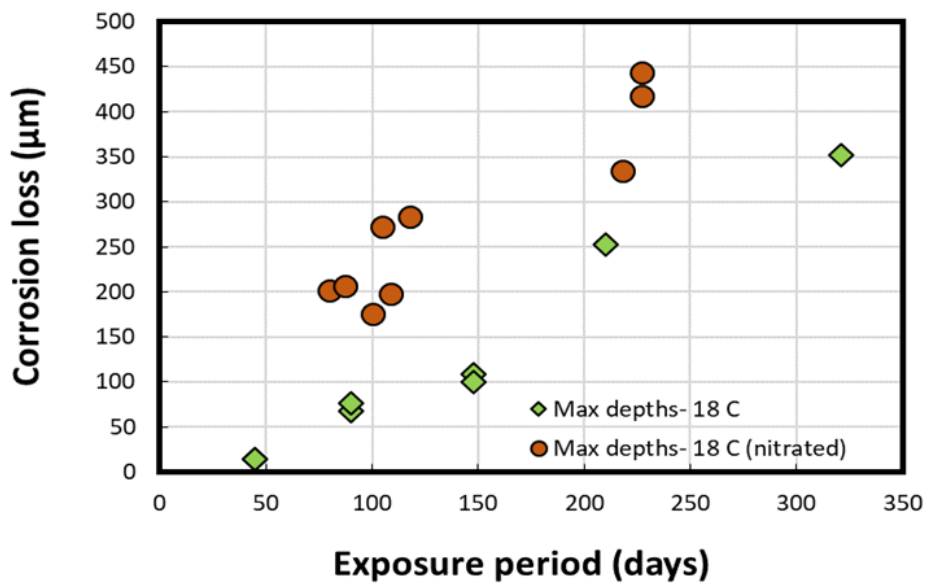
Figure 7 Comparison of maximum corrosion depths observed on steel coupons exposed to the nitrated artificial seawater (J-series), the un-nitrated artificial seawater (C-series), and calculated using DM-micrometry method

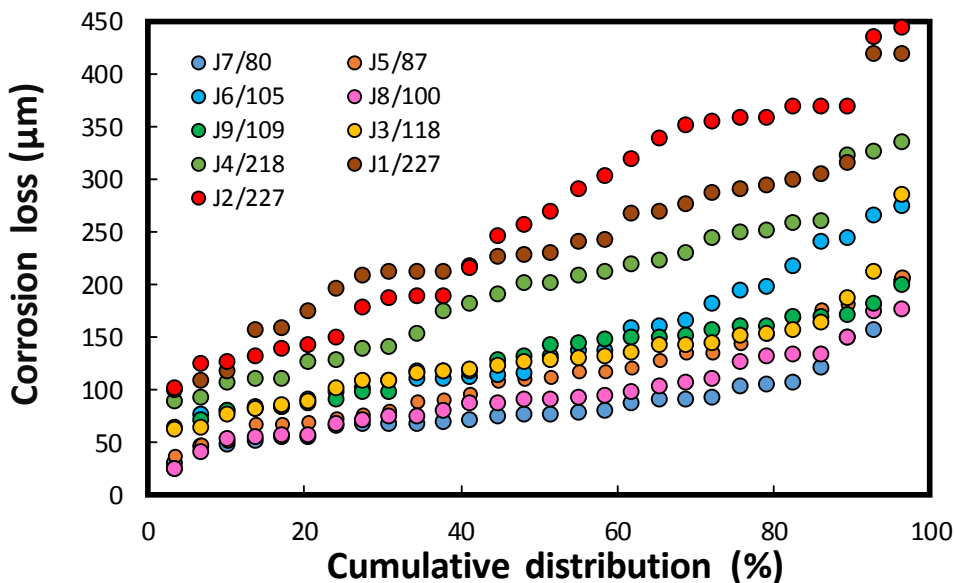
Figure 9 Cumulative probability distribution (%) of corrosion losses for J-series steel coupons exposed to the nitrated artificial seawater. Here, J indicate the name of steel coupon and the number after slash shows the duration of exposure (in days)

nitrate seawater solution (in Figure 9), the maximum corrosion depths ranged between 0.4-0.45 mm after maximum exposure duration of 227 days. Similar to the corrosion trend in un-nitrated seawater, here (Figure 9) the rapidly increasing trend of corrosion depths is more significant after first 200 exposure days.

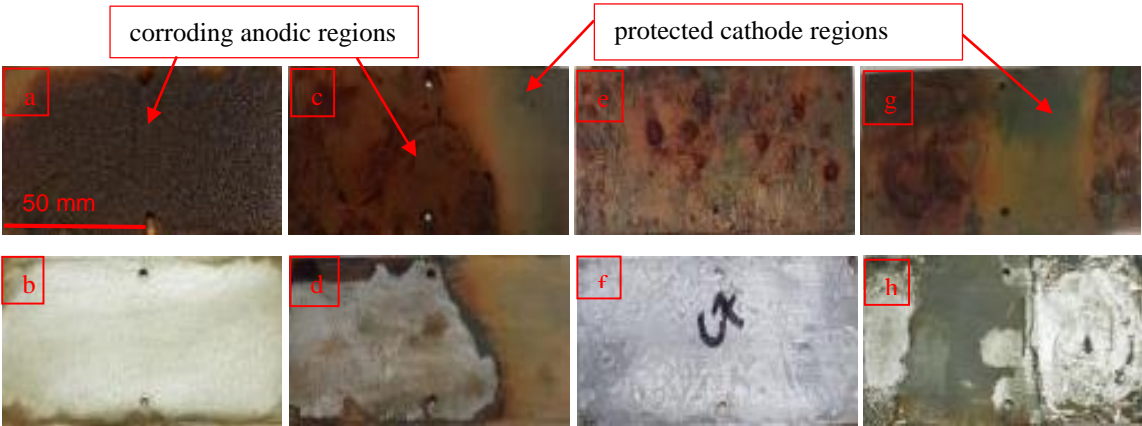
Figure 10 shows the macrographs of the corroded steel coupons of C-series, exposed to the un-nitrated artificial seawater at 18°C. The cathode regions were protected by a hard greyish protective layer which remained intact throughout the exposure period. On the coupons collected after 250 days of exposure, the protective layers developed on the cathode regions were hard enough that they could not be removed completely even after chemical cleaning and mechanical brushing.

Figure 10 Pictorial view of the corroded and chemically cleaned steel coupons (C-series) collected from artificial seawater. Here exposure periods are as follows: (a, b) 45 days (c, d) 90 days (e, f) 210 days and (g, h) 321 days

On the anodic regions, a powdery, soft, and bright reddish/orange coloured corrosion deposits were formed at a slower rate, which possibly represents the unstable lepidocrocite phase. Further, on these coupons, the innermost corrosion layers (near metal surface) did not turn into blackish oxides for the first 150 days, however, the blackish layers were observed on the coupons collected after 210 and 321 days of seawater exposure.
